**MARYLAND HISTORICAL TRUST  
NR-ELIGIBILITY REVIEW FORM**

Property Name: Mill Inventory Number: HO-420

Project: Owens Property Agency: Corps of Engineers

## INVENTORY FORM FOR STATE HISTORIC SITES SURVEY MAGI#1404205714

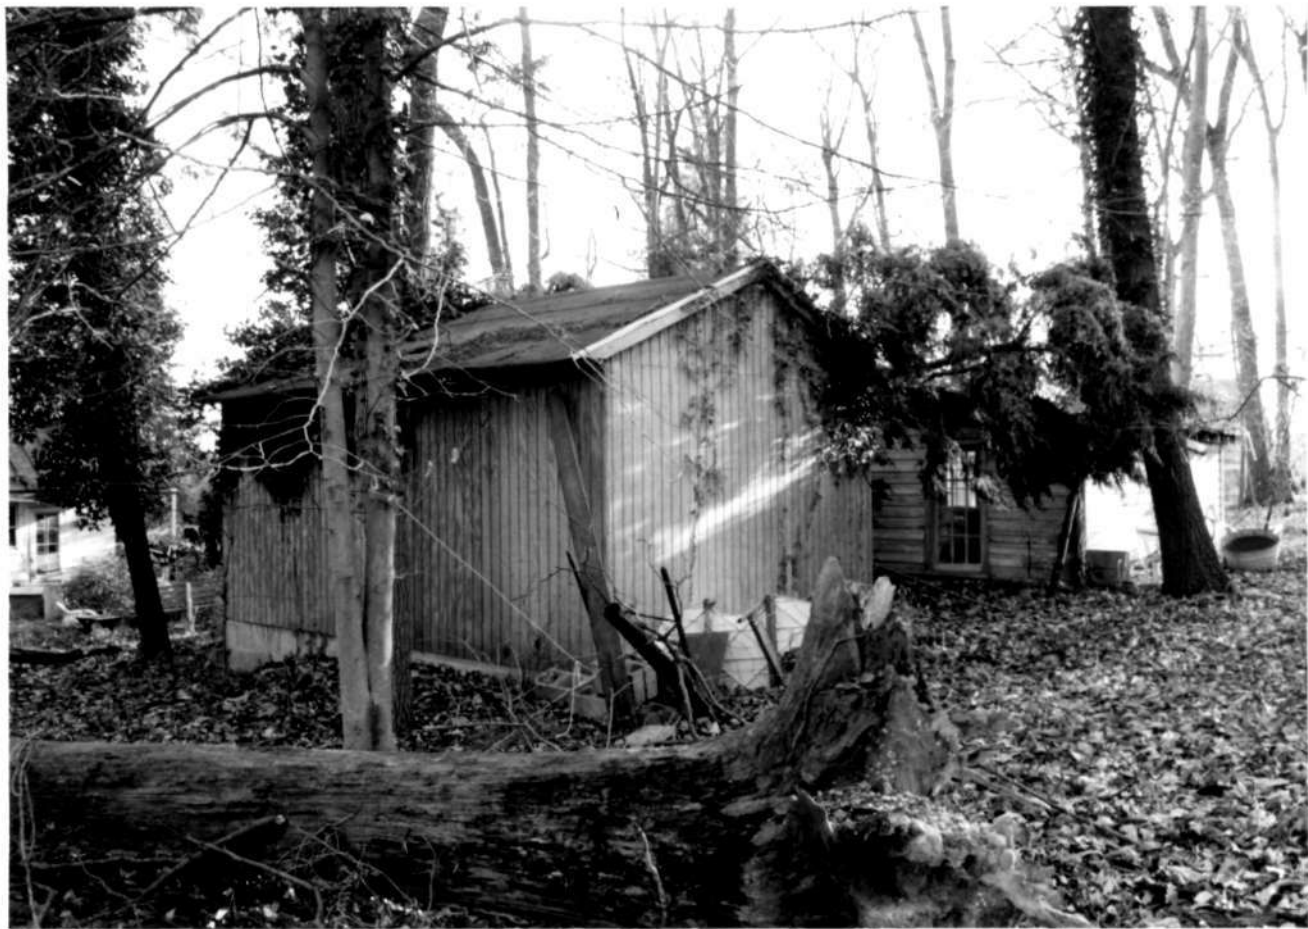
17/24

The **well house**, constructed ca. 1985, is located northwest of the house and northeast of the garage. The wood-frame, one-story building faces southwest and occupies a rectangular footprint. The well house rests on a concrete-block foundation. Exterior walls are clad with vertical T1-11 siding. The shed roof is sheathed in asphalt shingles. The building has a single, off-center door on the front elevation and no windows. The interior walls are partially insulated. The well house is in fair condition. A large tree has fallen on it.

Main House Well House, view S

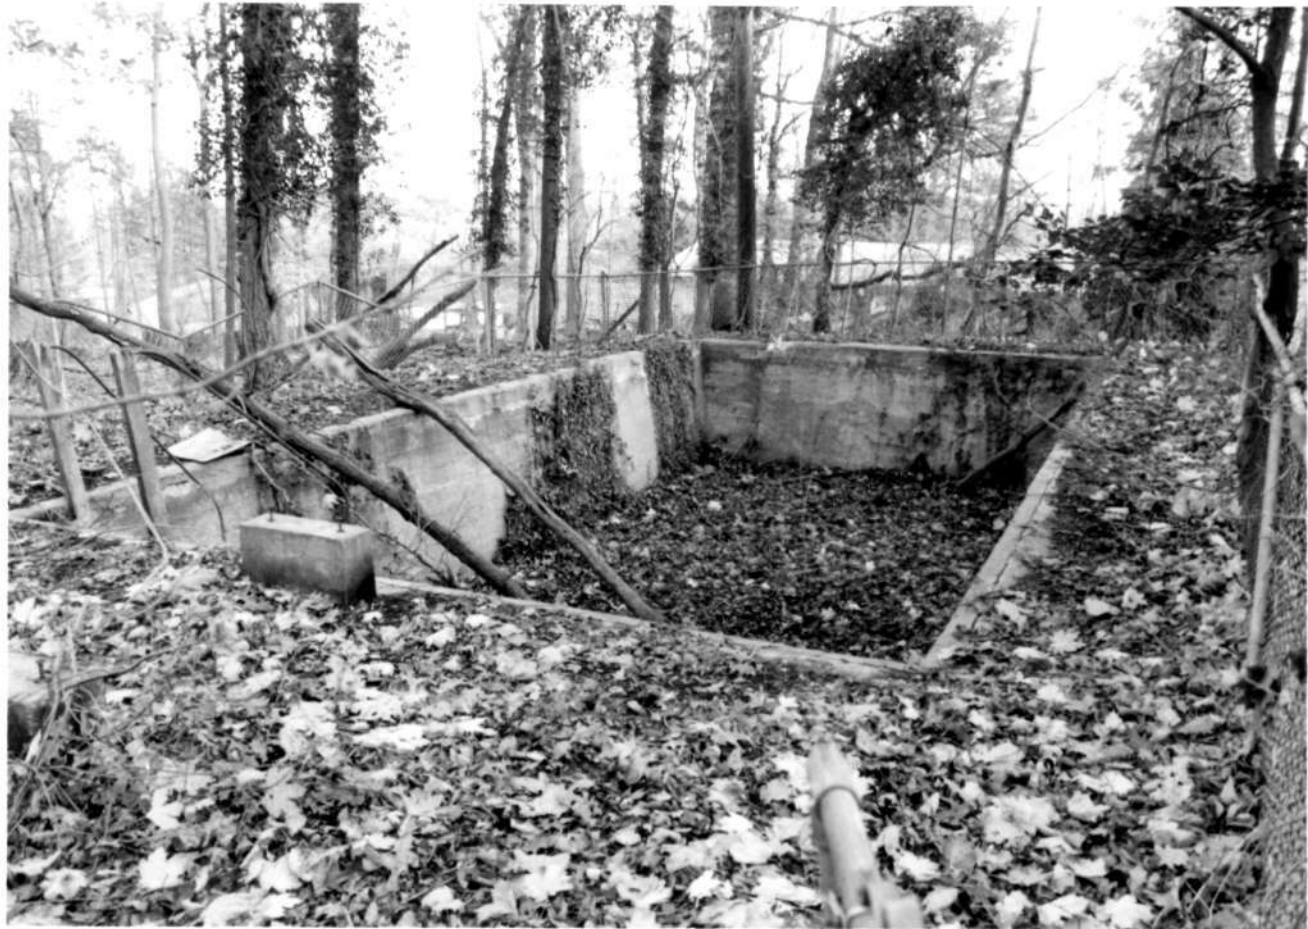
18/24

The **swimming pool**, constructed ca. 1915, is located east of the house. The concrete-block pool has a depth of approximately eight feet. Mounting blocks for a diving board are located on the northwest end. A concrete patio and a wire fence with plastic-coated mesh surround the pool.

Main House Swimming Pool, view E

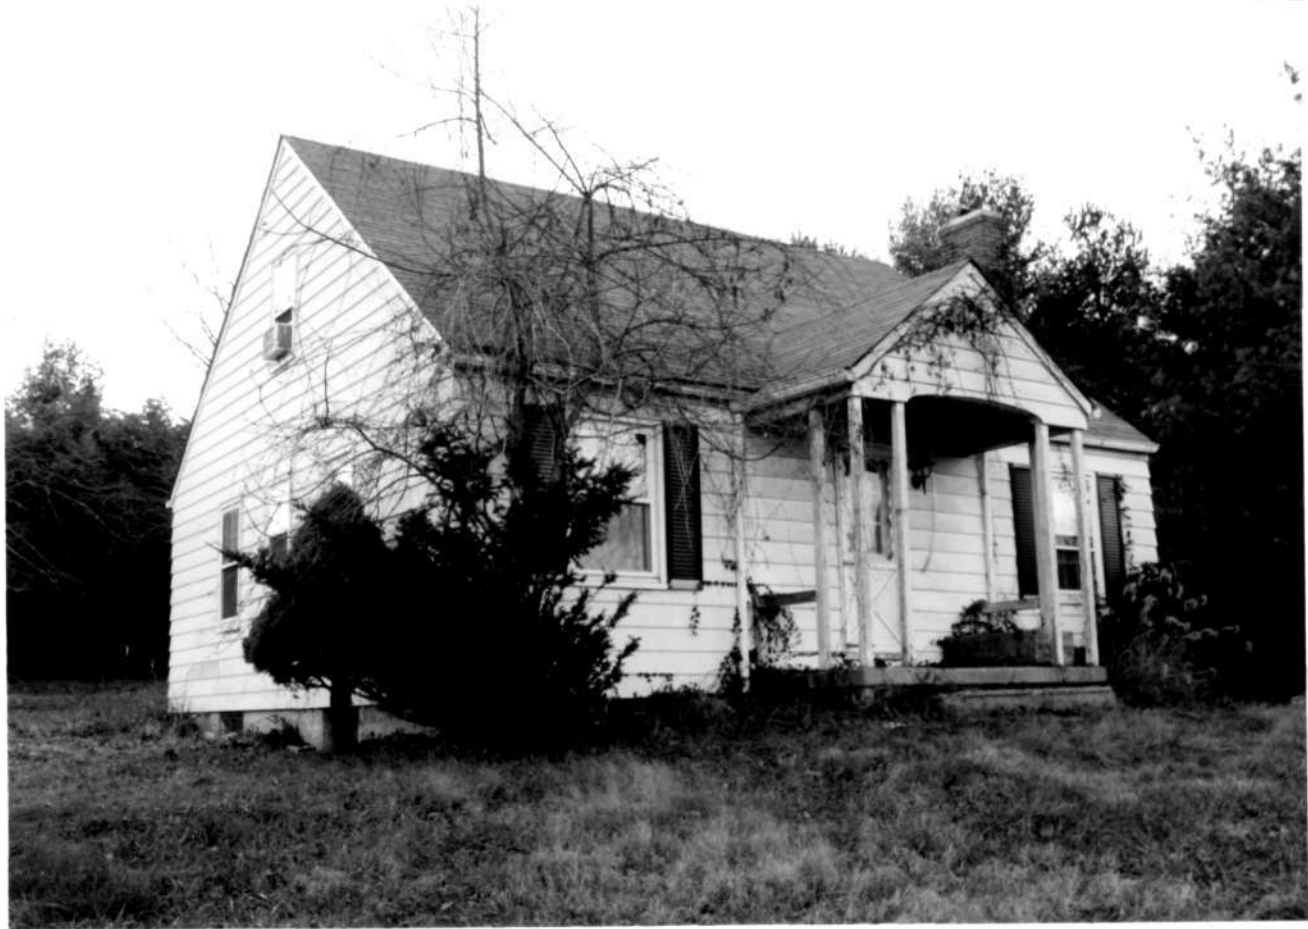
19/24

**House No. 2**, constructed ca. 1940s, is located at 5016 Landing Road. The dwelling occupies a slight elevation at the end of a gravel driveway. The house is surrounded by an unkempt yard with a hedge and a row of white pines on the northwest side. A garage is located behind the house. The wood-frame, one-and-one-half-story, three-bay house faces northeast and occupies a

rectangular footprint. The building rests on a rusticated concrete-block foundation. Exterior walls are clad with aluminum siding. The gable roof is sheathed in asphalt shingles. An exterior brick gable-end chimney rises from a rusticated concrete-block base on the northwest elevation. Two gabled dormers clad with aluminum siding are located on the rear elevation. Each dormer contains a wood-frame, six-over-six-light, double-hung sash window. Similar windows are located on all elevations of the house, with the exception of three replacement windows and one louvered glass window. A single wood door with nine lights is centered on the front elevation. The one-bay front porch has a front-facing gable roof clad with aluminum siding and supported by wood posts. The porch has a rusticated concrete-block foundation, cement steps and floor, and a beaded-board ceiling. A six-panel metal door is located on the northwest elevation. This side door is sheltered by a concrete porch with a gable roof supported by wood posts. The house is in good condition. The aluminum siding is discolored in some locations.

House No. 2, view W

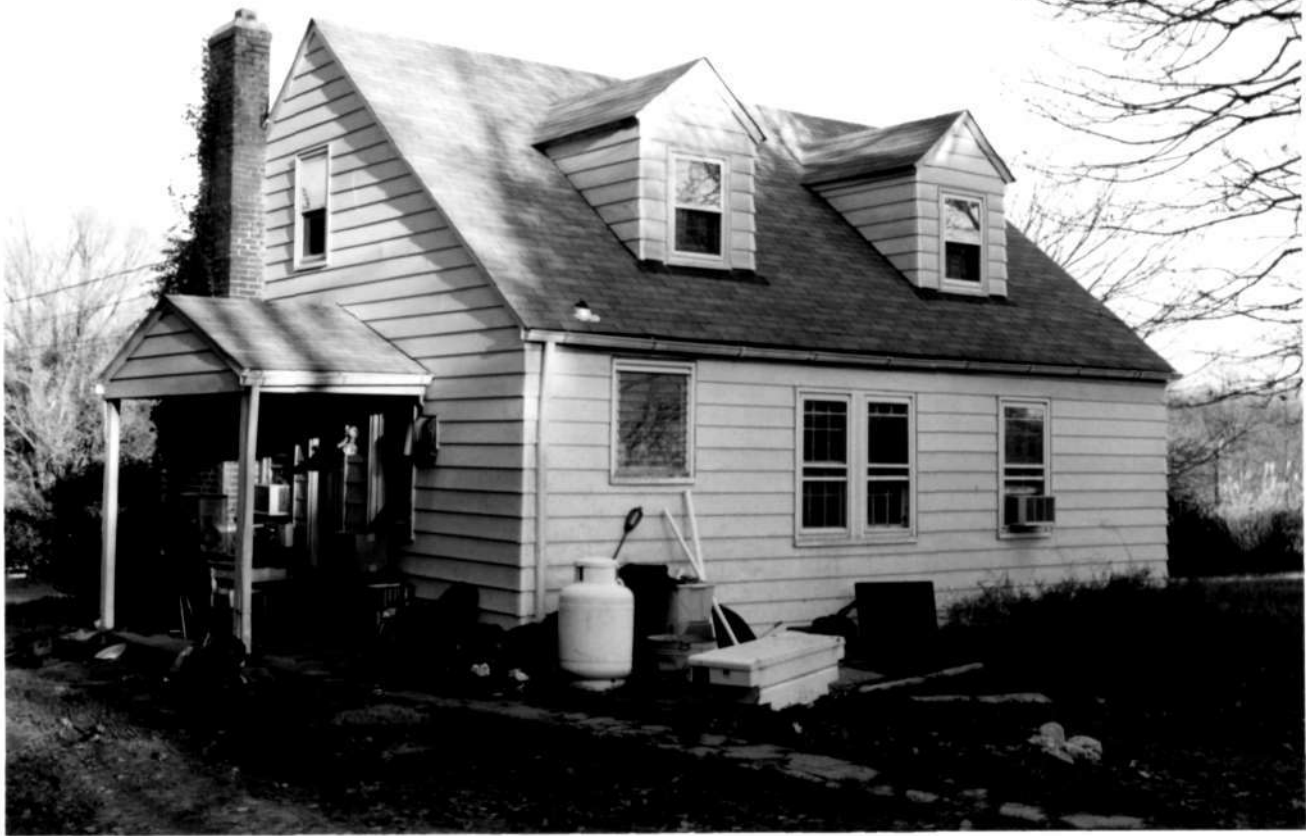
20/24

House No. 2, view E

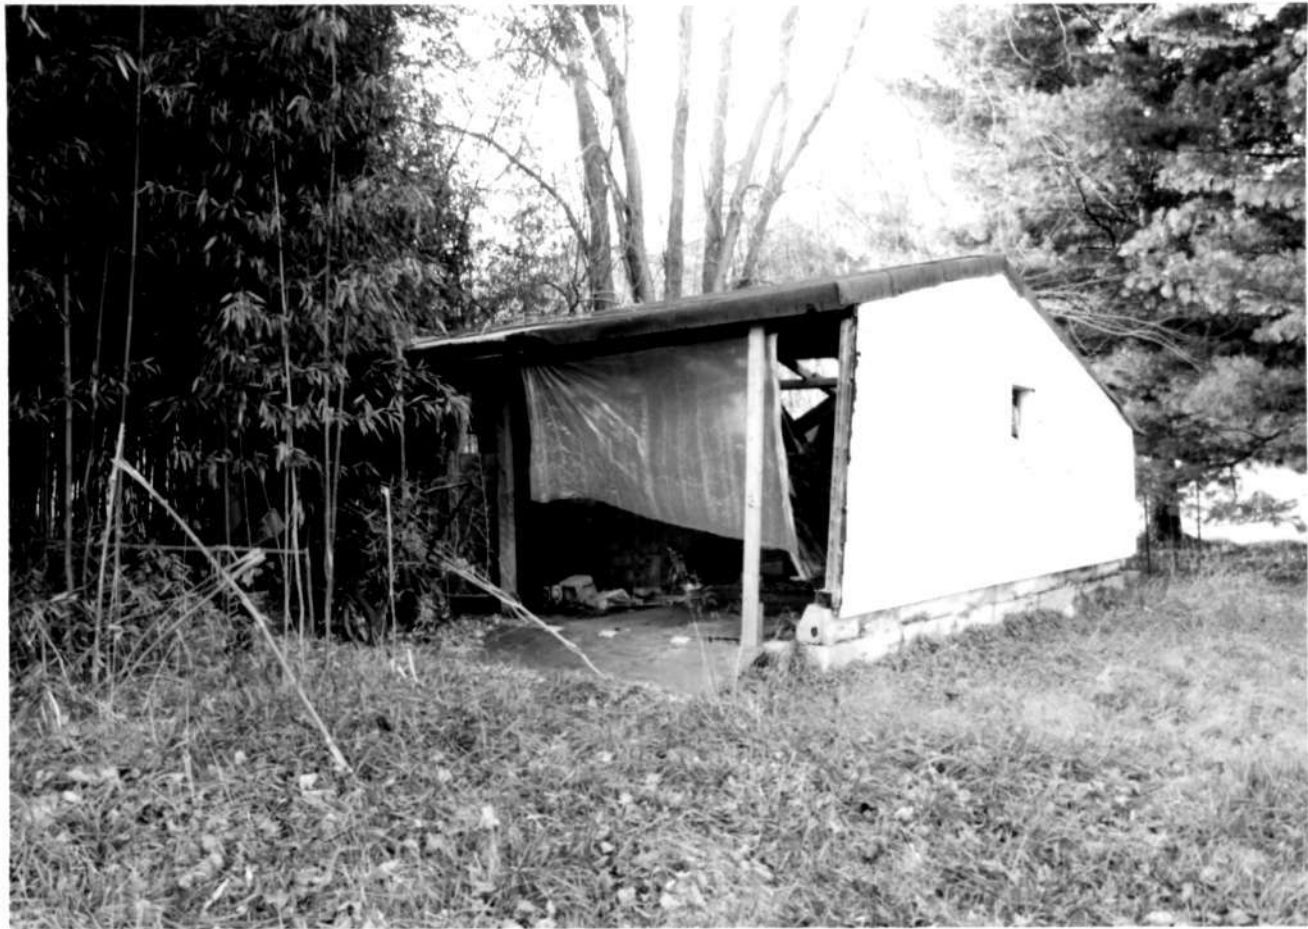
21/24

The **garage**, constructed ca. 1940s, is a wood-frame, one-story building that faces southeast and occupies a rectangular footprint. The building rests on a concrete-block foundation and has a concrete floor. Exterior walls are clad with vinyl siding and asbestos shingles. The irregular gable roof is sheathed in composition roll roofing. The front elevation remains open, and no doors are present. A wood door is located in the southwest elevation. The building has window openings, but windows are gone. The garage is in poor condition. The concrete-block foundation is cracked. Moss and mold grow on the foundation and walls. The building leans to one side and the roof is collapsing.

House No. 2 Garage, view W

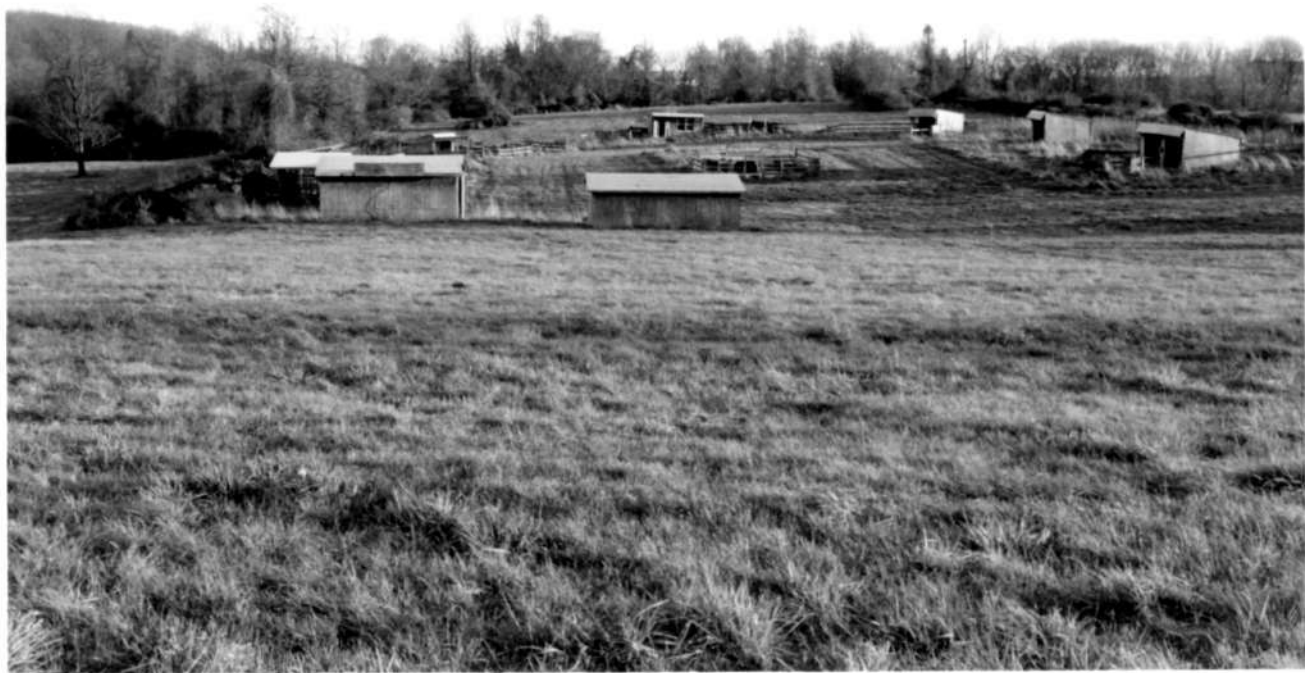
22/24

The **petting zoo**, constructed ca. 1985, is a collection of wood-frame buildings arranged in a flat field at the bottom of the slope from the main house. The buildings stand in a circular layout, facing center. A wood-rail fence encloses half the perimeter. The petting farm includes a concession building, three aviaries, six walled animal pens, and one open animal pen. Buildings are either square or rectangular, and some have a poured-concrete floor. The concession building faces southwest, is clad with vertical T1-11 siding, and has a front-facing gable roof sheathed in asphalt shingles. The front elevation features a single central door and a wood-frame, six-over-six-light, double-hung sash window. Concession window openings are located on the front and side elevations. The aviaries have wire mesh wrapped around their wood frames. The walled animal pens are clad with vertical T1-11 siding. Their shed roofs are sheathed in composition roll roofing and feature front wood awnings. The central open animal pen consists of a concrete slab enclosed by a wood-rail fence. The petting zoo buildings are in fair condition.

Petting Zoo, view SE

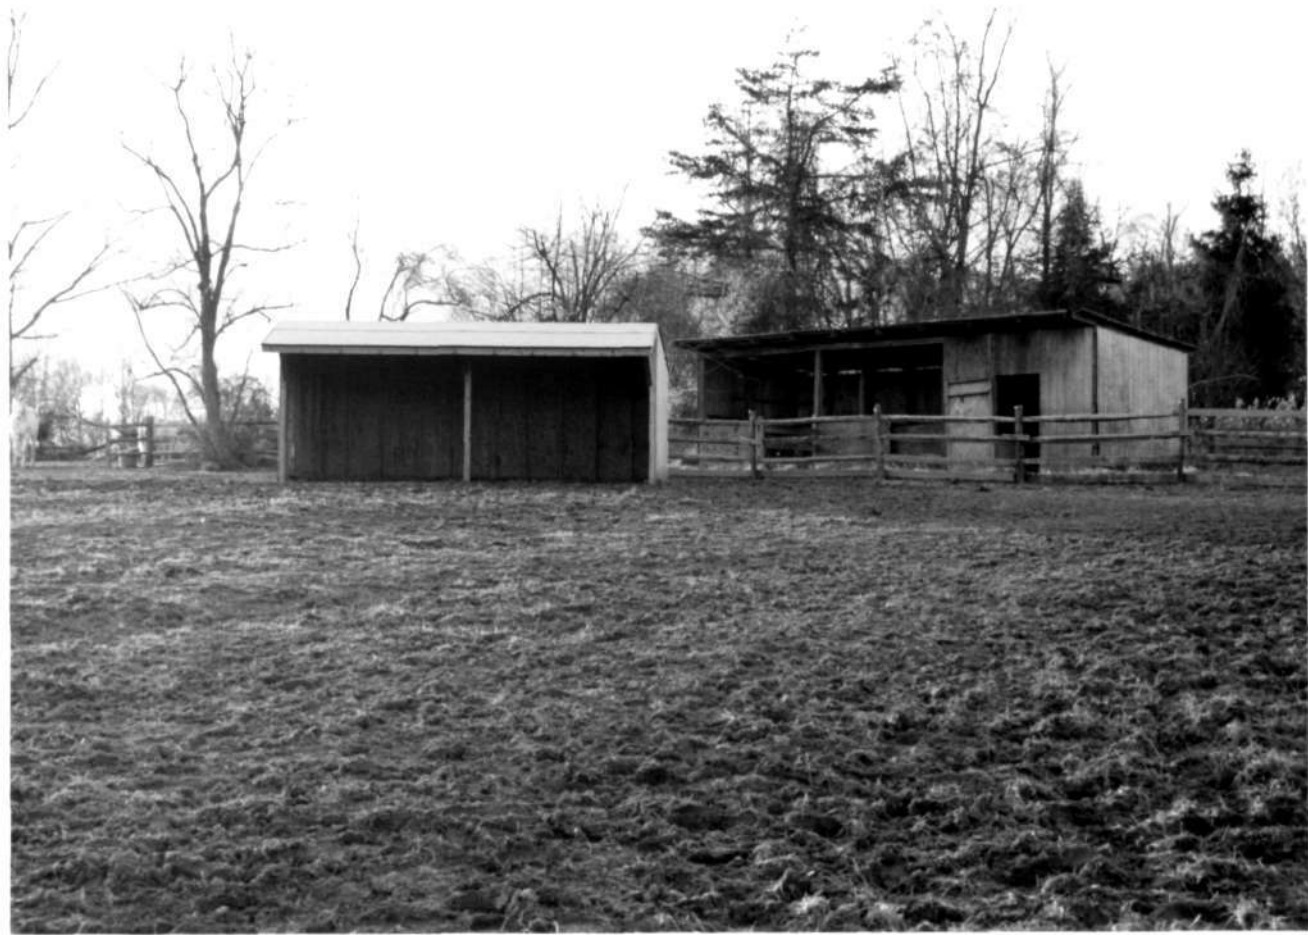
23/24

Two animal pens for horses are located west of the petting zoo. These wood-frame buildings are clad with vertical T1-11 siding and have shallow shed roofs. The larger pen, constructed ca. late 1980s, is a three-bay building with metal roof sheathing. The smaller pen, constructed ca. late 1990s, is a two-bay building with a front wood awning and composition roll roofing. Each pen is adjacent to a horse pasture enclosed by a split-rail fence. The pens are in fair condition.

Animal Pens (Horses), view W

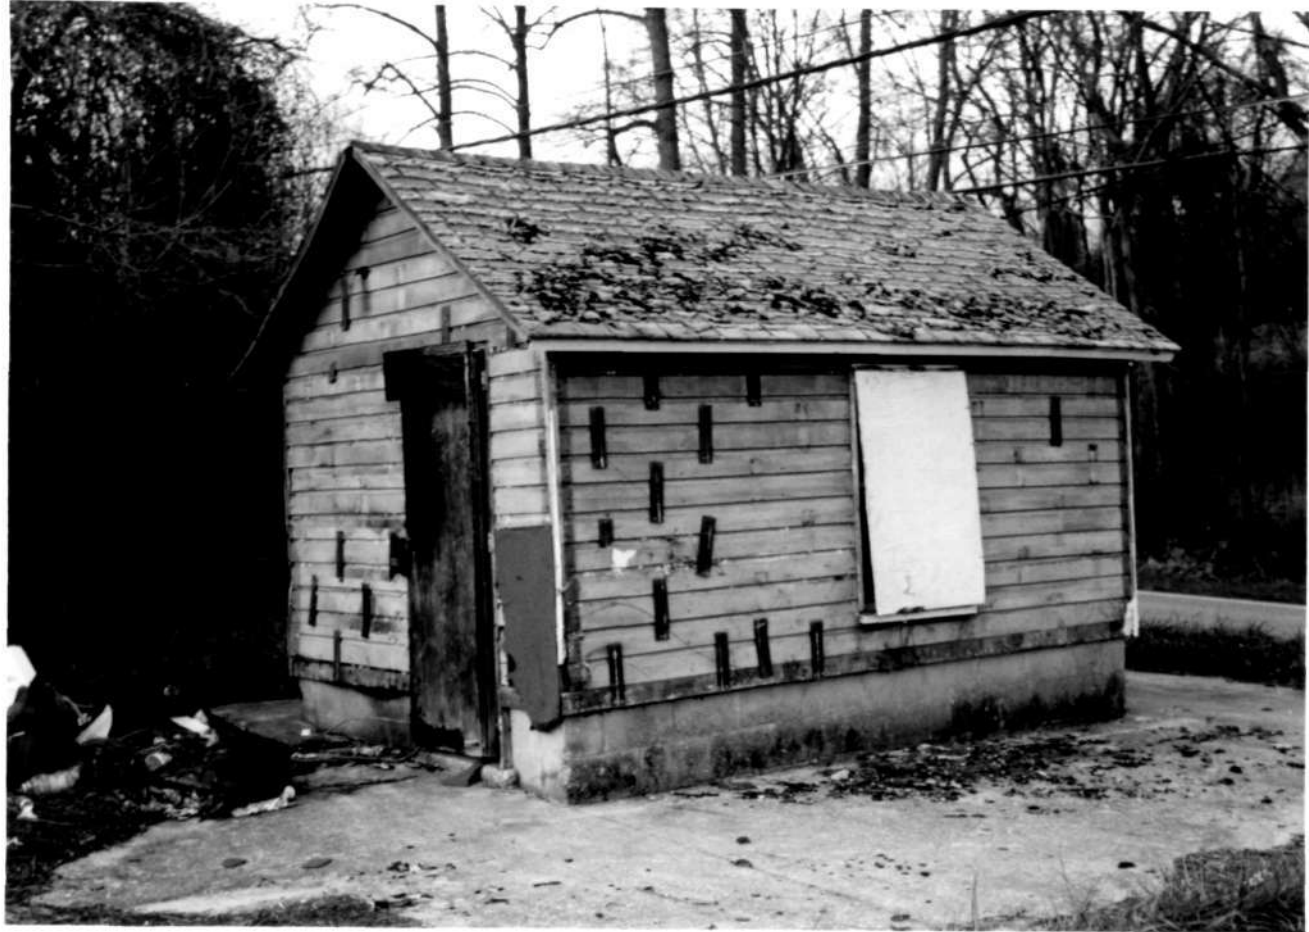
24/24

A **utility building**, constructed ca. 1920s, is located on the east side of the Owens Property, close to Landing Road. The wood-frame, one-story building faces southwest and occupies a rectangular footprint. The building rests on a concrete-block foundation. Exterior walls are clad with drop wood siding. The front-facing gable roof is sheathed in asphalt shingles. A single plywood door is centered on the front elevation. A wood-frame window is located on the east elevation. The utility building is in fair condition.

Utility Building, view N
